COSMOPOLITAN CHRONICLE

SAN DIEGO, ALTA CALIFORNIA, APRIL 11, 2008

THE ART OF HISTORIC DETECTION

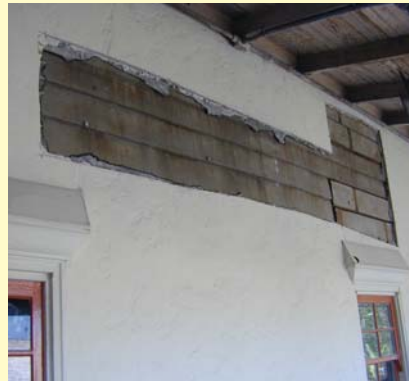
The cement stucco dates back to the 1930 renovation undertaken by Cave Coutts Jr. It is layered over chicken wire and tar paper, which, in turn, covers the mill sawn redwood clapboard installed by Albert Seeley as siding in 1869 for his hotel.

The boards are approximately six inches in height with a narrow top or lip, which widens toward the base. The base of the adjoining board overlaps or covers about 1 1/2 inches of the other board’s lip. The heavy residue of lead-base paint suggests that the siding was originally reddish brown.

Clapboard siding helped to economize on nail usage—in this case, the lip and base of the adjoining boards were held in place with a single nail. Seeley’s

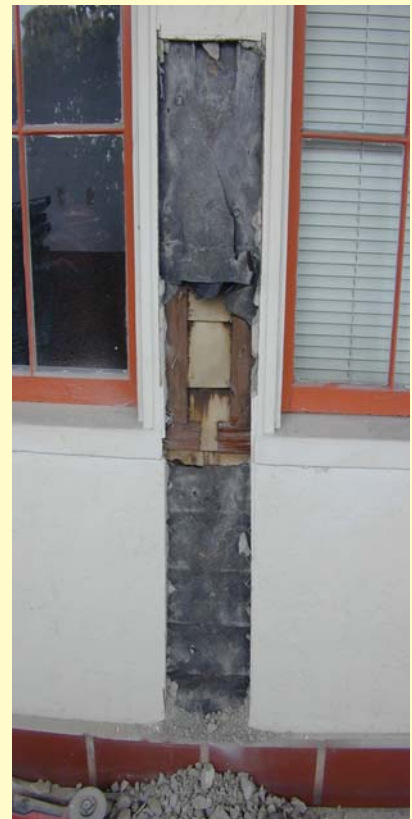
Samples of the hotel’s original redwood door and window trim have also been uncovered, along with imprints of the original window sills. The sills extend further out than the existing sills installed in 1930.
